## SERVICE BULLETIN

Note No.	SVC-FSB-0053
Release Date	04/30/2018
Contact	ngceoservice@ngc.com

# Error Code 0806 Troubleshooting

This bulletin serves as an instruction guide for troubleshooting the error code 0806 on the 4U eDrive.

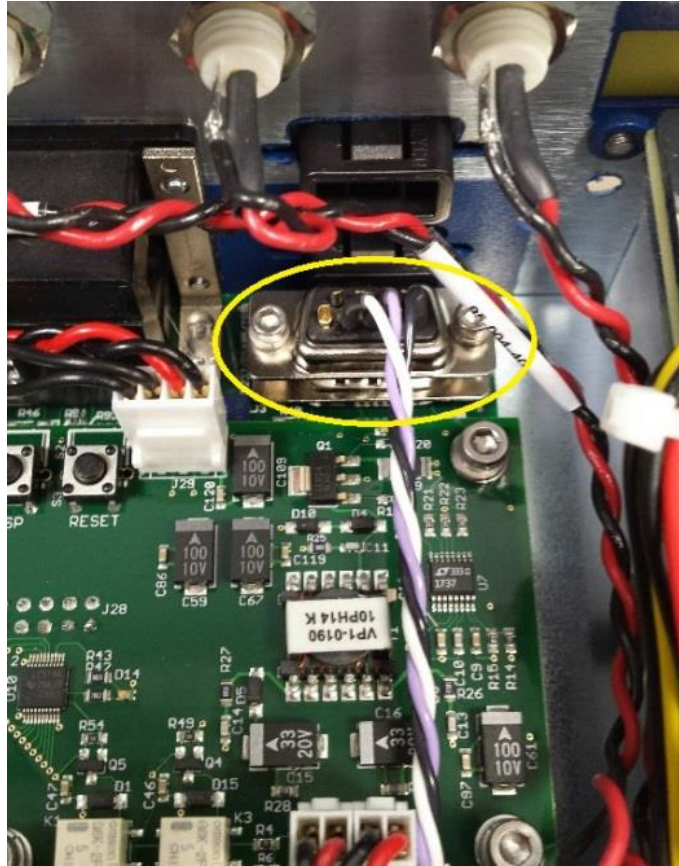
Figure 1

1. Power down the eDrive and unplug from power source.
2. Using a Phillips® screwdriver, remove the 22 screws from the top cover.
3. Gently lift the cover off of the top of the driver and set aside.
4. Locate the System Controller and verify that the communication cable (purple/black/white) is connected. See **Figure 1** for details.

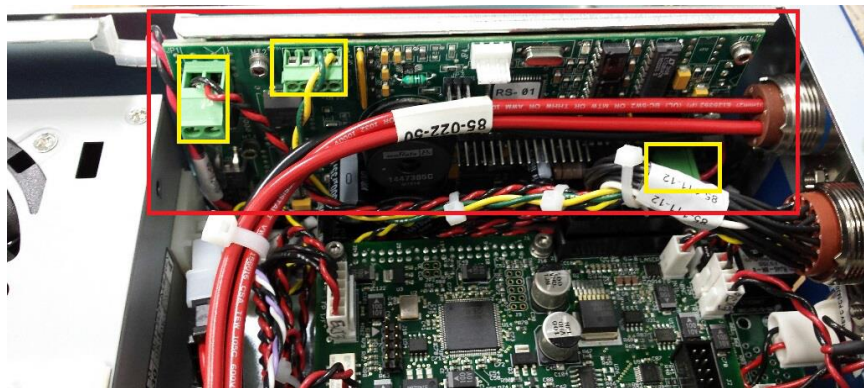
Figure 2

5. Locate the TEC board (circled in red in **Figure 2**). Use a flat screwdriver to ensure that the three connections in yellow are good and tight.

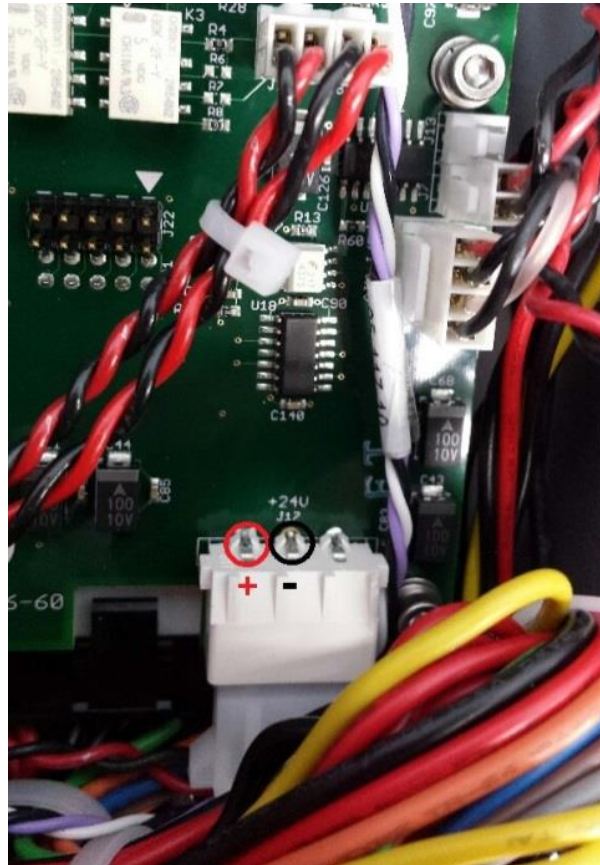
Figure 3

7. Check for 28 V DC on **J17** on the Expansion Module. This will verify that the 28 V Power Supply is functional. See **Figure 3** for location and test points.

8. If all connections are good and there are 28 volts present, the TEC board has failed. The most common failure on the TEC board is the Communications Crystal. The Service Bulletin *Internal TEC Controller Crystal Replacement* (SVC-FSB-0022) can be found on the Knowledge Center. This Service Bulletin gives instruction on how to replace this crystal.
9. If 28 V is not present, then turn the eDrive over and remove the bottom cover. Reseat the power connection to the LPS255 power supply.

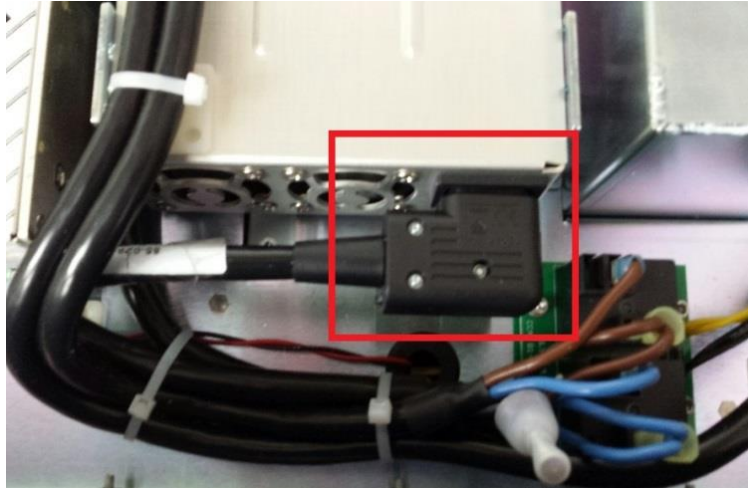
Figure 4. LPS255 28 V Power Supply

10. After reseating the LPS255 power connection, retest the 28 V at the Expansion Module. If 28 V is not present, then replace the LPS255 power supply.
